Manhole Inspection Summary

Manhole # S33K1_014MH

Insp Date: **3/25/08 11:23 AM**

Location Address: **2838 Potte St.**

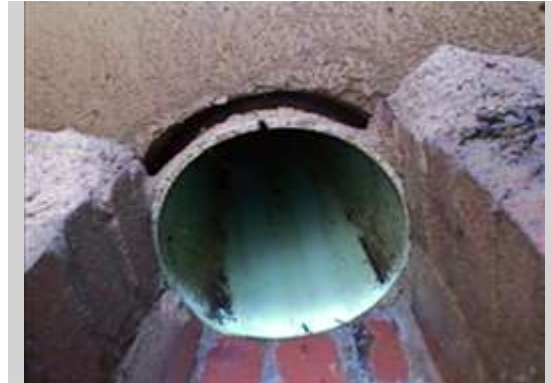
12 O'Clock Outflow
Pipe Out @ 12 O'Clock

Pipe Height: **9.6** (in.) Rod and Bar (Angled)
Pipe Material: **PVC** ☐ Pipe Lined
Invert Depth: **10.09** (ft.) Flow Characteristics: **Slow**
Deposits: ☒ None ☐ Mud ☐ Sludge ☐ Debris ☐ Grease
Silt Depth: (in.) Deposits Extent:
Infiltration: **None** Pipe Seal Cond: **Sound**

Drop: **None**

Connects To: **Manhole**

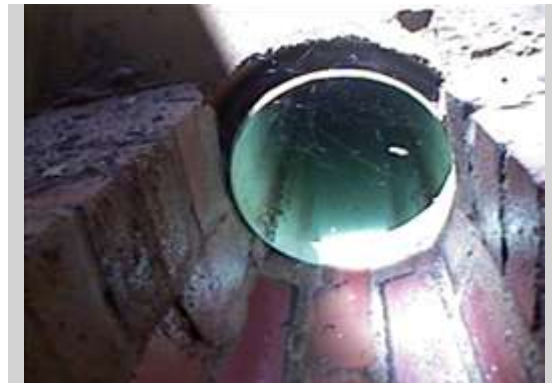
7 O'Clock Inflow
Pipe In @ 7 O'Clock

Pipe Height: **9.6** (in.) Rod and Bar (Angled)
Pipe Material: **PVC** ☐ Pipe Lined
Invert Depth: **10.20** (ft.) Flow Characteristics: **Slow**
Deposits: ☒ None ☐ Mud ☐ Sludge ☐ Debris ☐ Grease
Silt Depth: (in.) Deposits Extent:
Infiltration: **None** Pipe Seal Cond: **Sound**

Drop: **None**

Connects To: **Dead End**
